W Z G HOME INSPECTION PROPERTY INSPECTION REPORT

Condominium - 0 Bedrooms - 0 Bathrooms – Open Parking Lot

INSPECTION SUMMARY REPORT

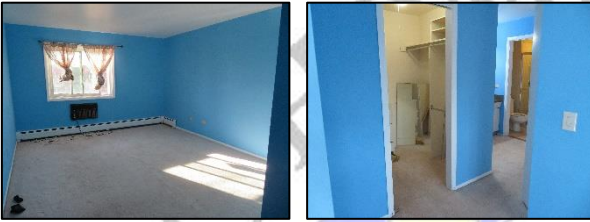
10. LEFT REAR MASTER BEDROOM:

Wooden doors – carpet – thermal pane windows – walk in closet with built in cabinets and drawers – electric baseboard heaters – drywalls – smoke detector.

- a. OUTLETS REVERSE POLARITY MEANS THAT NEUTRAL AND HOT WIRES ARE REVERSE WHICH CAN RESULT OF POSSIBLE SHOCK HAZARD AND **CORRECTION BY A QUALIFIED ELECTRICIAN IS STRONGLY RECOMMENDED.**

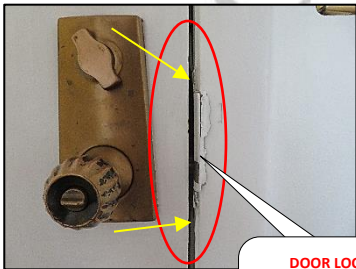
- a. THE UNIT EXTERIOR DOOR IS NOT WEATHERTIGHT/ LOOSE. THIS EFFECTS ENERGY EFFICIENCY; LOOSING HEAT SOURCE ON WINTER AND COLD AIR ON SUMMER. CORRECTION BY A QUALIFIED DOOR CONTRACTOR IS RECOMMENDED.

- b. DOOR DEADBOLT LOCK NOT FASTENED TO THE DOOR FRAMES OR LATCH – THIS IS A SAFETY HAZARD AND MAY CAUSE OF PERSONAL INJURIES. RECOMMEND TO CHECK AND CORRECTED BY QUALIFIED CARPENTER PRIOR TO CLOSING.

DOOR LOCK NOT FASTENED TO THE DOORS AND LARGE GAP ON DOORS

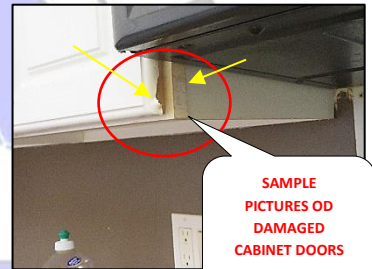
MINOR CORNER DAMAGED CABINET LAMINATED FASCIA/ COVERS WAS OBSERVED.

SAMPLE PICTURES OD DAMAGED CABINET DOORS

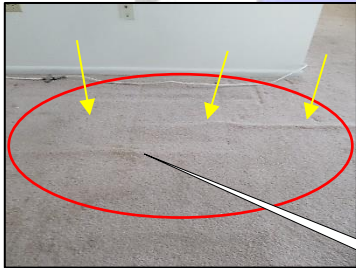
- e. LOOSE AND BULGING CARPET COVERING WAS OBSERVED – THIS IS A SAFETY HAZARD AND MAY CAUSE PERSONAL INJURY IN CERTAIN CIRCUMSTANCES; CORRECTION OF QUALIFIED CARPET CONTRACTOR IS RECOMMENDED.

- e. LOOSE CARPET COVERING WAS OBSERVED – THIS IS A SAFETY HAZARD AND MAY CAUSE PERSONAL INJURY IN CERTAIN CIRCUMSTANCES; **CORRECTION OF QUALIFIED CARPET CONTRACTOR IS RECOMMENDED.**

SAMPLE PICTURES OF LOOSE DAMAGED AND BULGING CARPET COVERING

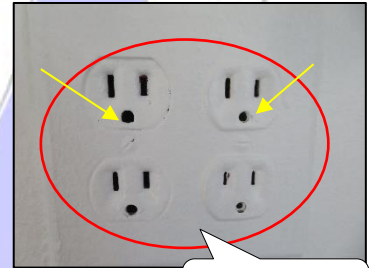
- a. BROKEN LOOSE WINDOW LOCKS WAS OBSERVED, THIS IS A SAFETY HAZARD AND MAY CAUSE PERSONAL INJURIES AND INSECTS ENTRY WAYS; **CORRECTION OF QUALIFIED WINDOW INSTALLER IS RECOMMENDED.**
- b. THE ELECTRICAL OUTLETS ARE PAINTED OVER. THIS IS A FIRE HAZARD. **CORRECTION OF QUALIFIED ELECTRICIAN IS RECOMMENDED.**

OUTLETS PAINTED OVER

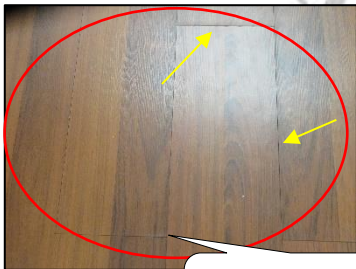
- a. THE GARBAGE DISPOSAL IS NOT WORKING AT THE TIME OF INSPECTION. A POSSIBLE DISCONNECTED POWER SUPPLY, UTILITIES WAS SHUT- OFF OR UNIT MECHANISM WAS DAMAGED. EVALUATION AND CORRECTION OF QUALIFIED PLUMBER OR TECHNICIAN IS RECOMMENDED. ALSO, THAT YOU (CLIENT) VERIFY TO THE OWNER THE PAST CONDITION PRIOR TO CLOSING.
- b. LOOSE LAMINATED FLOOR COVERINGS AND DAMAGED EDGES WERE OBSERVED – THIS MAY CAUSE PERSONAL INJURY IN CERTAIN CIRCUMSTANCES; **CORRECTION OF QUALIFIED FLOOR CONTRACTOR IS RECOMMENDED.**

SAMPLE PICTURES OF DAMAGED AND LOOSE KITCHEN FLOOR COVERINGS

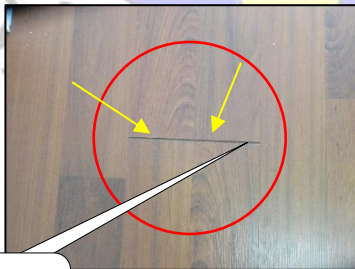
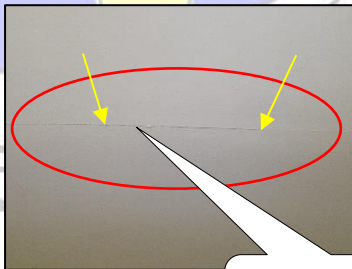
HAIRLINE CRACKED ON CEILING.

- f. THE MINOR CEILING CRACKS WERE TYPICAL AND MAY BE PATCHED AS DESIRED, BUT MAY RE- OCCUR DUE TO NORMAL SEASONAL CHANGES, MONITORING OF THE CRACKING IS SUGGESTED AND **FURTHER EVALUATION AND CORRECTION BY A QUALIFIED CONTRACTOR IS STRONGLY RECOMMENDED.**

SAMPLE PICTURES OF CRACKED AND BUCKLING CEILING

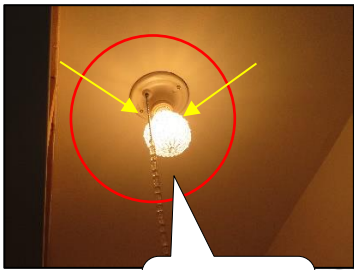
- d. BARE BULB LIGHT FIXTURE OR LAMPHOLDERS OBSERVED INSIDE THE CLOSET; MISSING GLOBES OR COVERS. THIS IS A FIRE HAZARD AND RISK FROM ANY FLAMABLE ITEM THAT CONTACT THE HOT BULB. **CORRECTION OF QUALIFIED AND LICENSED ELECTRICIAN IS RECOMMENDED.**

MISSING LIGHT FIXTURES COVERS OR SHIELD

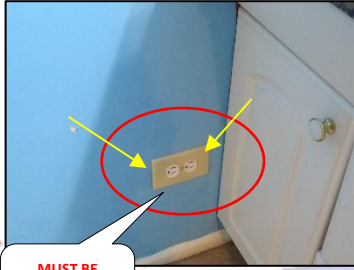
- b. THE WALL OUTLETS NEAR SINK WAS NOT GFCI PROTECTED. THIS IS A SAFETY HAZARD. SINCE 1996 NEC REQUIRED THAT ALL 20 AMPERES RECEPTACLE AT KITCHEN COUNTERS AND EVERYWHERE IN ANY BATHROOM REQUIRES GFCI PROTECTION INCLUDING THOSE APPLIANCES IN GARAGES AND CLOSE TO WATER SOURCE. CORRECTION OF QUALIFIED ELECTRICIAN IS RECOMMENDED.

MUST BE GFCI OUTLETS

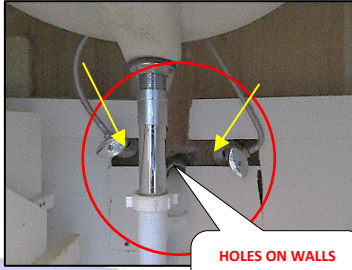
- a. LARGE HOLES ON WALLS AROUND PLUMBING PIPES WAS OBSERVED UNDER SINK CABINETS. THIS IS A FAILURE HAZARD AND MOISTURE INTRUSION OR VERMIN ENTRY WAY. **RECOMMEND TO REPAIR BY A QUALIFIED CONTRACTOR PRIOR TO CLOSING.**

HOLES ON WALLS UNDER SINK CABINETS

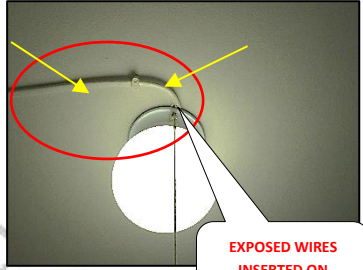
- g. BARED ELECTRICAL WIRES INSERTED INTO LIGHT FIXTURES ON CEILING. THIS IS A FIRE HAZARD AND MAY CREATE ELECTRIC SHOCK. **CORRECTION OF QUALIFIED ELECTRICIAN IS STRONGLY RECOMMENDED.**

EXPOSED WIRES INSERTED ON LIGHT FIXTURES

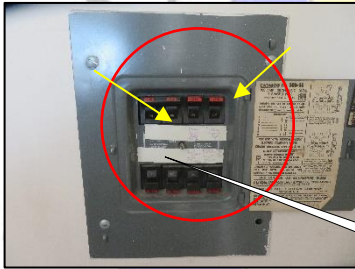
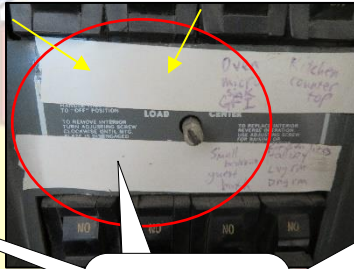
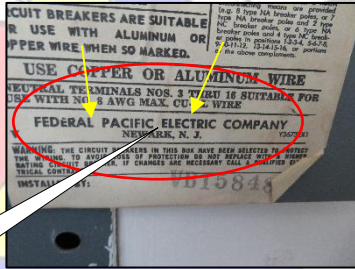
- b. THE PANEL WAS AN FPE STAB- LOK OR ZINSCO WHICH IS WELL DOCUMENTED TO HAVE A HIGH RATE OF FAILURE AND IS A FIRE HAZARD. FURTHER EVALUATION BY A QUALIFIED ELECTRICIAN IS STRONGLY RECOMMENDED. FOR FURTHER INFORMATION ON THE PANELS, PLEASE TYPE “ZINSCO OR FEDERAL PACIFIC ELECTRIC” INTO AN INTERNET SEARCH ENGINE.

- c. OBSERVED ROOM LABELS FOR OVERCURRENT PROTECTION DEVICES (BREAKERS OR FUSES) IN THE MAIN ELECTRICAL PANEL BOX IS MISSING OR INCOMPLETE. INSTALATION AND CORRECTION OF QUALIFIED AND LICENSED ELECTRICIAN IS HIGHLY RECOMMENDED.

SAMPLE PICTURES OF FEDERAL PACIFIC BREAKERS AND INCOMPLETE ROOM LABELS
