WZG HOME INSPECTION
An Illinois Licensed Home Inspector
Website: www.homeinspection-wzg.com

PROPERTY CONDITION ASSESSMENT
wzghomeinspection@yahoo.com
773-771-4978
"High Quality Inspection for Client's Satisfaction"

Inspection Date: December 00, 0000 Outside Temp: 35° Cloudy Soil condition: Wet soil Entry door faces: West
Time: 09:00 am Utilities at the time of inspection: Gas is on Electric is on Water is on Requested by: Client
Present at Inspection: Buyer, Bldg. Manager, Agent & Tenants Building type: Mix - used - 6 units
Property Address: # 00123456 Sample Ave, Illinois 0000

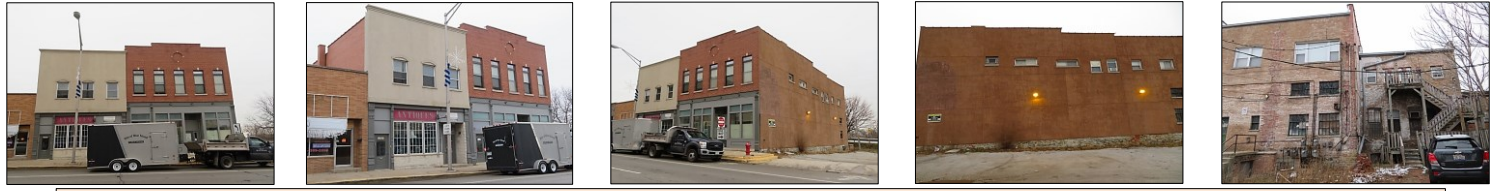
Sample pictures of EXTERIORS; Front West, North West, South West, South and rear East Elevation: Brick, wooden and stucco exteriors - light fixtures - thermal and casement windows - wooden porch - flat rubber roofs with steel gutters and down spout - City poured concrete walkway - vacant lot on South sections of the property.

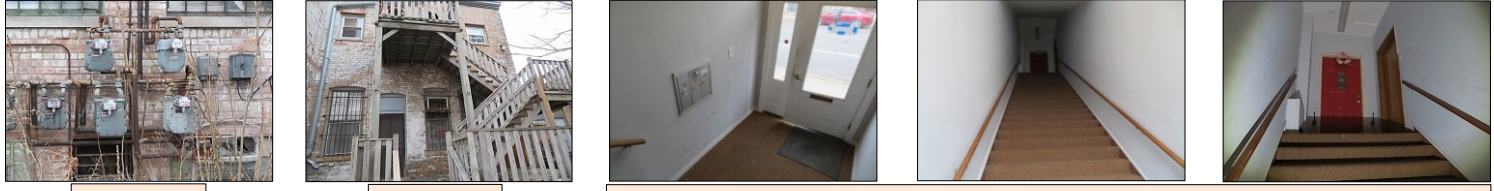
GAS METERS REAR WOODEN PORCH FRONT COMMON STAIRS & LOBBY (13125 ENTRY): Steel doors with glass panes - carpet wooden stairs with carpet coverings - light fixtures - mailboxes - drywalls - radiator heater

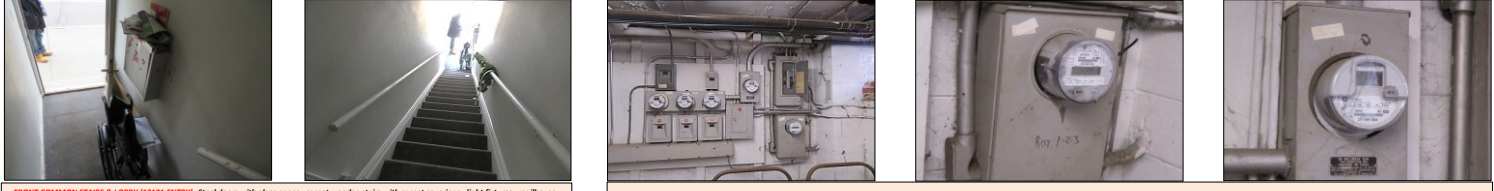
FRONT COMMON STAIRS & LOBBY (13121 ENTRY): Steel doors with glass panes - carpet wooden stairs with carpet coverings - light fixtures - mailboxes - drywalls - radiator heater. ELECTRICAL SYSTEMS: Overhead service drop inlet wires - STABLOCK/FEDERAL PACIFIC/PUSHMATIC BREAKERS - 150 Amperes, step down to 100 amperes per unit - located on basement areas and sub panel on each unit.

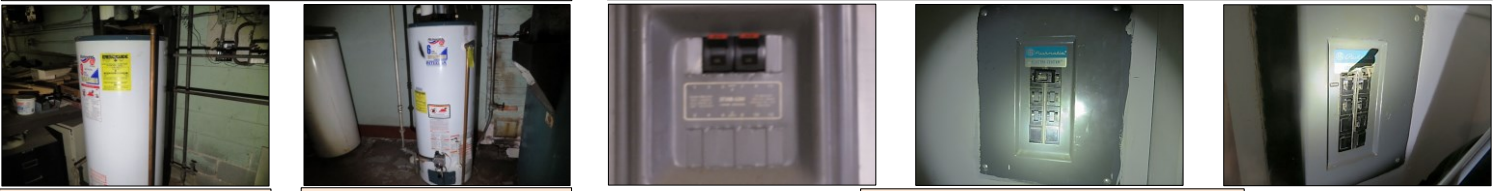
WATER TANK HEATER: Conventional - gas type - RICHMOND Brand - Model # 7K50 SERIAL # RMNG080218054 - CAPACITY - 50 U S GALLONS YEAR MANUFACTURED - 2000 - Located on basement area. WATER TANK HEATER: Conventional - gas type - RICHMOND Brand - Model # 6G50 SERIAL # RMALN267517655 - CAPACITY - 50 U S GALLONS YEAR MANUFACTURED - 12/2007 - Located on basement area. Sample pictures of Electrical PUSHMATIC panel box on each unit

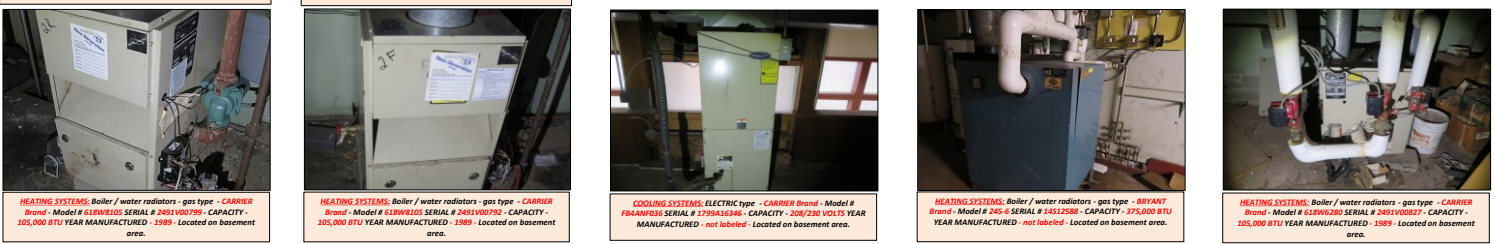
HEATING SYSTEMS: Boiler / water radiators - gas type - CARRIER Brand - Model # 618W6105 SERIAL # 2491V00759 - CAPACITY - 105,000 BTU YEAR MANUFACTURED - 1989 - Located on basement area. HEATING SYSTEMS: Boiler / water radiators - gas type - CARRIER Brand - Model # 618W6105 SERIAL # 2491V00752 - CAPACITY - 105,000 BTU YEAR MANUFACTURED - 1989 - Located on basement area. COOLING SYSTEMS: ELECTRIC type - CARRIER Brand - Model # F84ANF36 SERIAL # 1799A16346 - CAPACITY - 208/230 VOLTS YEAR MANUFACTURED - not labeled - Located on basement area. HEATING SYSTEMS: Boiler / water radiators - gas type - BRYANT Brand - Model # 245-S SERIAL # 14512580 - CAPACITY - 375,000 BTU YEAR MANUFACTURED - not labeled - Located on basement area. HEATING SYSTEMS: Boiler / water radiators - gas type - CARRIER Brand - Model # 618W6290 SERIAL # 2491V00827 - CAPACITY - 105,000 BTU YEAR MANUFACTURED - 1989 - Located on basement area.

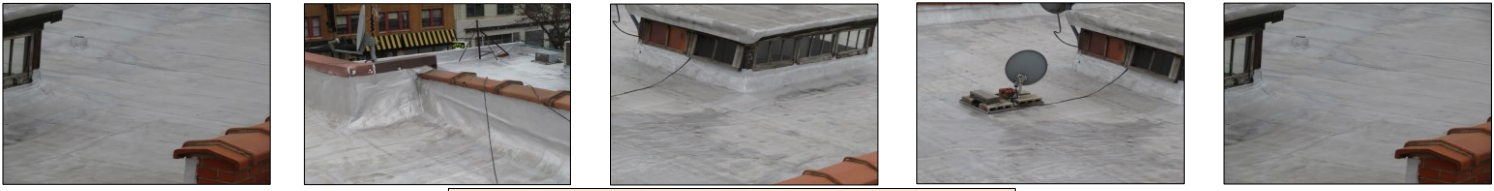
Sample pictures of ROOFING SYSTEMS: Flat rubber roof, roof tiles - steel gutters and down spouts
